ABSTRACT

The use of non-metallic composites is growing fast in various industries such as oil and gas sectors mainly in the form of pipes. Such pipes can be damaged which may cause major production failures or environmental mishaps. Traditional non-destructive testing (NDT) methods are mainly used for metallic pipes. Microwave imaging has been proposed as a promising approach for examination of multi-layer non-metallic pipes. Here, we demonstrate that the effect of undesired eccentricity of the multiple pipes can impose additional imaging errors. For the first time, we study this effect via simulations contaminated with artificial noise.

Near-field holographic imaging has been extended to inspection of multi-layer concentric non-metallic pipes [5,6]. Here, we study the performance of the near-field holographic imaging of double pipes with different eccentricity values, i.e., the centers of the two pipes are not perfectly aligned. We consider this factor for the first time and we use a quantitative measure, called reconstruction error (RE), to evaluate the degradation of the images of the defects on the inner and outer pipes of a double-pipe configuration due to various eccentrici

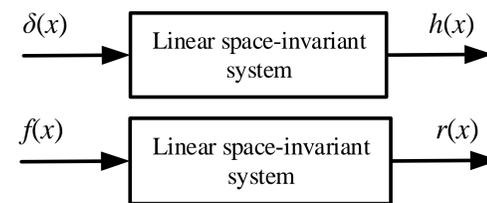
Fig.1. Block diagram of linear systems.

response for an unknown: $r(x) \approx f(x) * h(x)$

unknown function: $f(x) = k_s^2(x) - k_b^2(x)$

Approximation of the imaging system with a linear system:

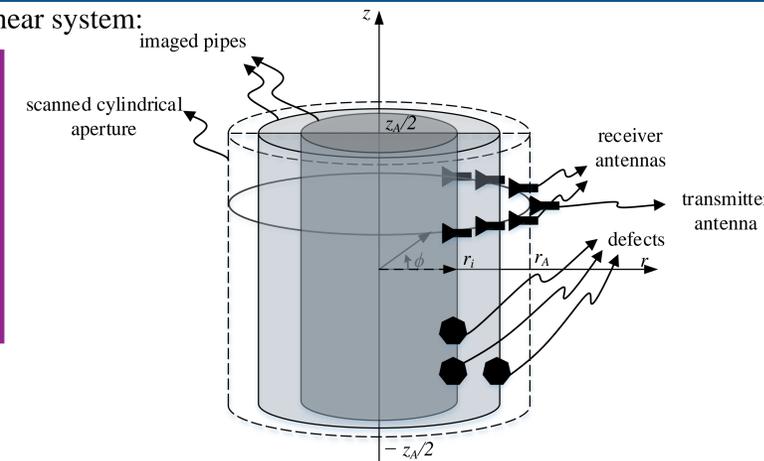
Fig.2. Illustration of the microwave imaging setup.

- Assumptions: linear imaging system, using one transmitter antenna and 12 receiver antennas, defects are infinite along the z axis
- Measure point-spread functions (PSFs) by putting small defects one at a time at the origin for each pipe
- Measure the responses of the defects over a circular aperture
- Use the theory of convolution and Fourier transform to construct systems of equations to be solved

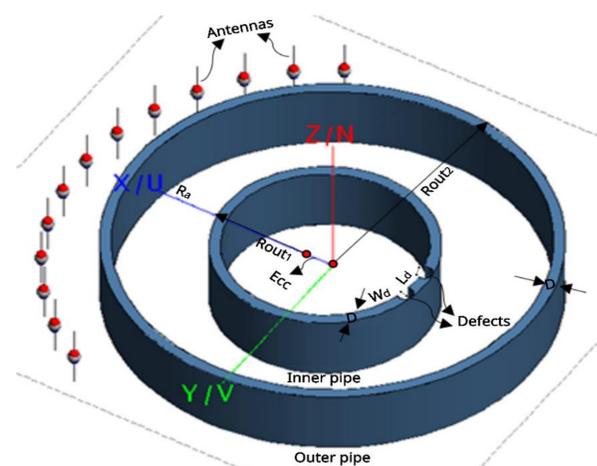
- Simulation study is performed using Altair FEKO software.
- Artificial noise of SNR = 20 dB is added for a realistic study.

Fig.3. Simulation setup.

TABLE I. PARAMETER VALUES FOR THE SETUP

$\Delta\phi_a$	R_a	R_{out1}	R_{out2}	D	L_d	W_d	$\Delta\phi_d$
10°	50 mm	20 mm	40 mm	2 mm	$1.5D$	$0.75D$	20°

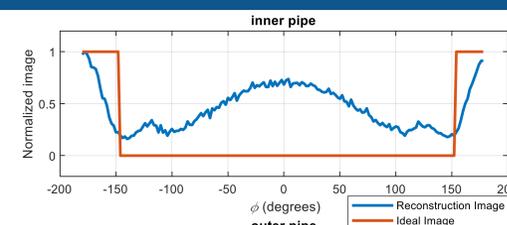
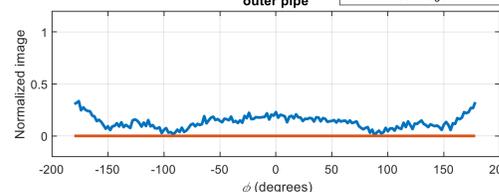
Fig.4. Reconstructed 1D image of inner pipe with ecc = 0.5mm.

The result shows deterioration of reconstructed image as the eccentricity increase.

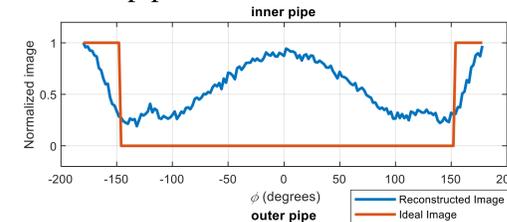
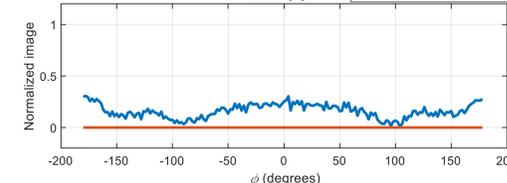
Fig.5. Reconstructed 1D image of inner pipe with ecc = 0.9mm.

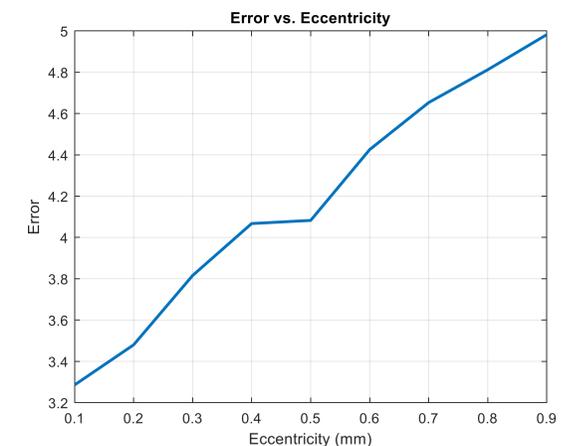
Fig.6. Variation of computed RE vs. eccentricity.

Overall, the results indicate that the quality of the reconstructed images is highly sensitive to non-zero eccentricity values such that even an eccentricity of 0.5 mm imposes image quality deteriorations. It was also observed that the images of the defects on the inner pipes would be affected more seriously by non-zero eccentricity effects.
